KVID Infrastructure Update Project

Infrastructure Refurbishment Evaluation

Revision 1.3

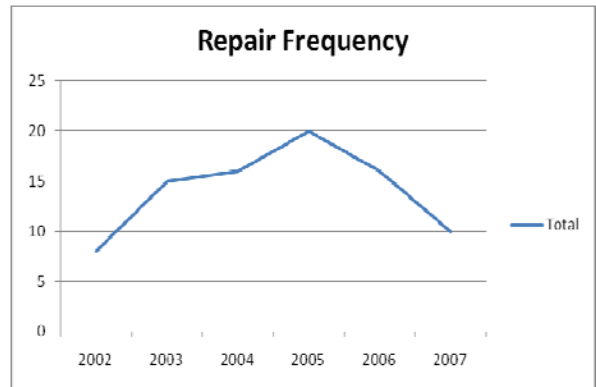
The evaluation indicated that imminent failure of the system is highly unlikely. It can only be noted that the repair frequency between 2002 and the end of 2007 peaked in 2005 and has decreased through today. The failure rate in 2007 is only slightly higher than the 2002 failure rate. This does not indicate a rising failure rate as illustrated by the bathtub curve explained in the Fourth Alternative Approach on page 9. In addition the Toho-Tolani paving project may have influenced the peak in 2005.

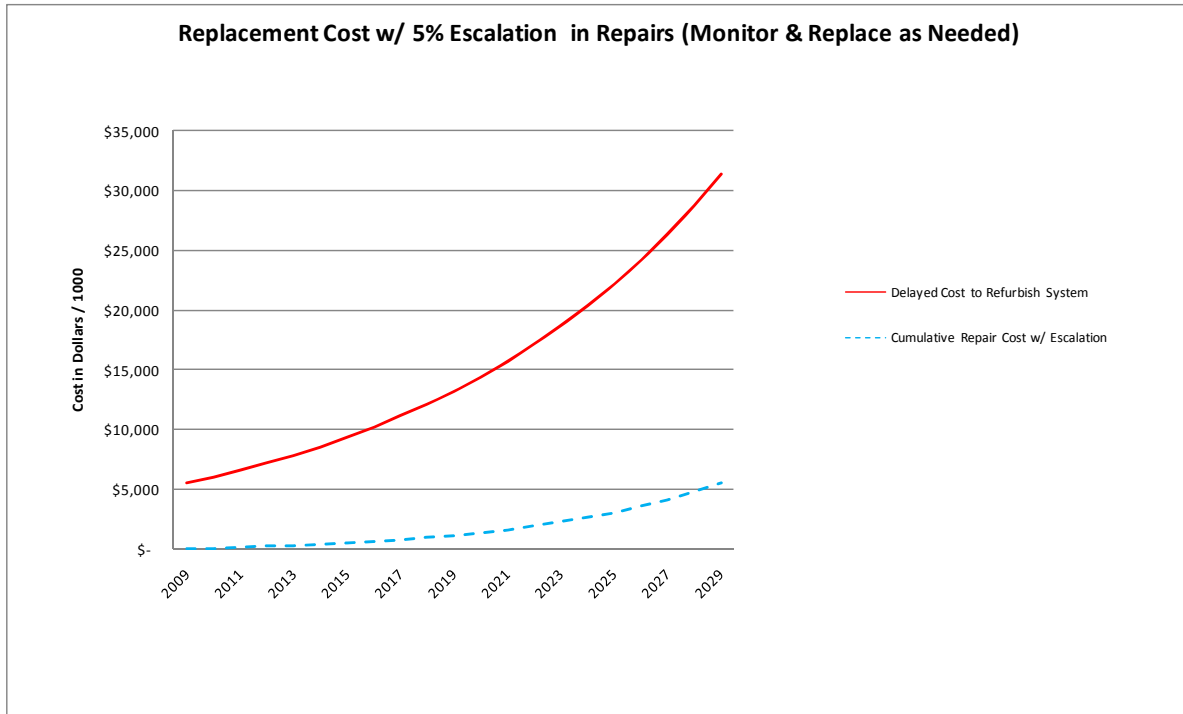
Figure 1 - Monitor & Replace as Needed

remedial action is taken. The dotted line represents the rising cost of repairs assuming the number of repairs increases by 5% per year and an annual escalation of horizontal construction/repair costs of 9%. As is evident by Figure 1 - Monitor & Replace as Needed, the cumulative cost of repairs in the year 2028 to 2029 time frame will be equal to the replacement cost in 2009.

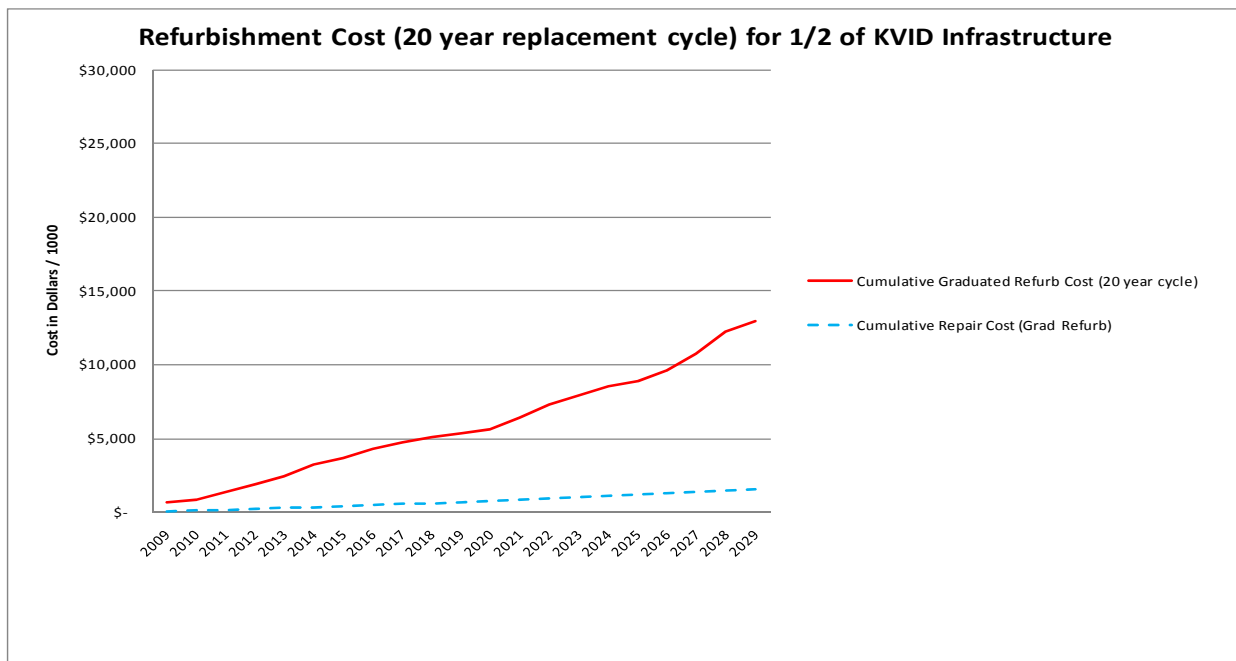
Figure 2 - 20 Year Replacement Cycle illustrates the *cumulative* cost of annual incremental replacement of the infrastructure over a twenty (20) year period. It is estimate that over a twenty (20) year period the total cost of replacement of the identified infrastructure will amount to approximately eleven million dollars and the cumulative repairs costs will be minimized to approximately one million dollars over twenty (20) years.

Several other replacement scenarios were tested but the one illustrated in Figure 2 appears to be a good cost option given the labor and time constraints on the utility. This scenario assumes incremental \$200K to \$600K (a significant number of dollars) replacement projects are undertaken each year. The size of the project (pipe run length) is projected from the GIS “Water Rehab” layer which segments the water piping into project size lengths for replacement.

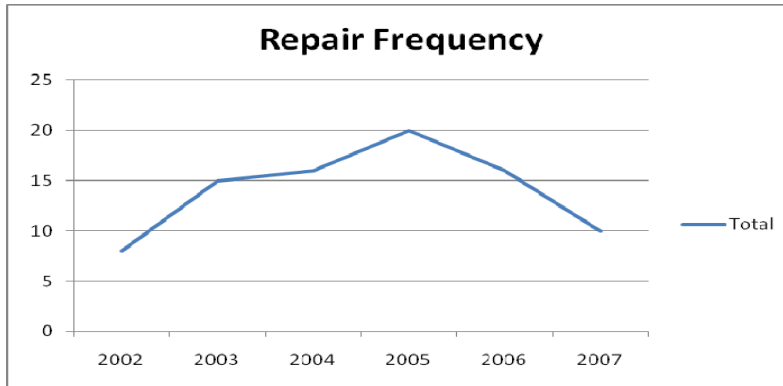
Figure 3 - Five Year Repair Frequency

We can only project that the failure rate of the piping infrastructure may follow this curve but there is no way of knowing at what point on the curve we are now operating. The failure rate as illustrated in Figure 3 - Five Year Repair Frequency, indicates we are not at the knee of the bathtub curve.

The fourth alternative is to continue tracking failure rates over the following years and attempt to identify the elbow point on the right. At that time it would be advantageous to implement a replacement/refurbishment program.
