KVID Infrastructure Update Project

Infrastructure Refurbishment Evaluation

Revision 1.3

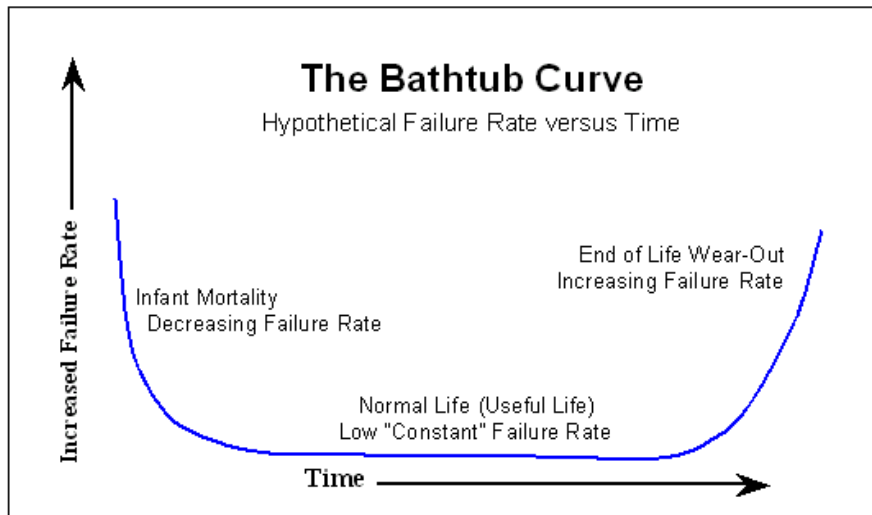
The projection of the repair costs is based upon a linear increase of problems of five percent per year. However, there is a relatively high probability that this does not reflect true reality. Dennis J. Wilkins, a retired Hewlett-Packard Senior Reliability Specialist states it well. "Reliability specialists often describe the lifetime of a population of products using a graphical representation called the bathtub curve. The bathtub curve consists of three periods: an infant mortality period with a decreasing failure rate followed by a normal life period (also known as "useful life") with a low, relatively constant failure rate and concluding with a wear-out period that exhibits an increasing failure rate." The graph (Weibull Distribution) demonstrates how infant mortality, normal life failures and wear-out modes combine to create the overall product failure distribution.

We can only project that the failure rate of the piping infrastructure may follow this curve but there is no way of knowing at what point on the curve we are now operating. The failure rate as illustrated in Figure 3 - Five Year Repair Frequency, indicates we are not at the knee of the bathtub curve.

The fourth alternative is to continue tracking failure rates over the following years and attempt to identify the elbow point on the right. At that time it would be advantageous to implement a replacement/refurbishment program.
